ANALYSIS OF THE CAPSIZE AND LOSS OF A 12000 DWT BULK CARRIER

Rumen Kishev, Bulgarian Ship Hydrodynamics Centre, r.kishev@bshc.bg
Vladimir Rakitin, Bulgarian Ship Hydrodynamics Centre, v.rakitin@bshc.bg
Silvia Kirilova, Bulgarian Ship Hydrodynamics Centre, s.kirilova@bshc.bg

ABSTRACT

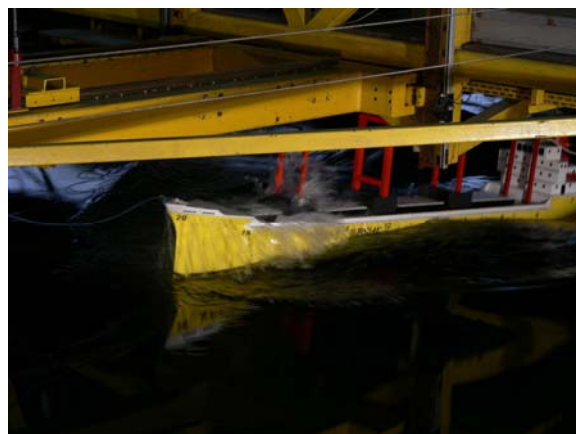
The results obtained show that motion parameters are within expected limits, the differences between three loading conditions being minor. However, at adverse headings (as was the case of forced storming after closing of the strait), the deck wetness intensity is very high – even at speed reduced down to 6 kn at Bf6 (H1/3 = 6 m), the number of deck wetness occurrence for loading case CH1 is about Ndw = 50, while good marine practice allows 30. This means that the bow part and the hatch cover of Hold № 1 in particular had been subjected to intensive loading by overwhelming waves. For loading cases CH2 and CH3 this intensity increases 1.5 – 2 times, due to effective freeboard decrease after flooding of the bow compartments.

Figure 2. Illustration of intensive deck wetness at head seas.

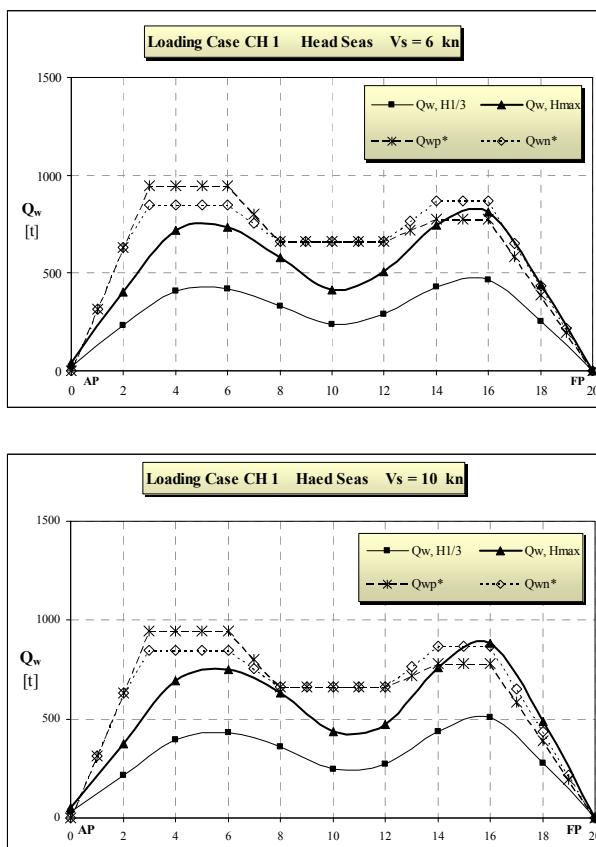
Figure 3. Shearing forces along the ship length as compared to the IACS allowable values.

It is well seen, that in head seas the resulting shear forces at the bow, in vicinity of Hold № 1, exceed the maximum allowable values in case of chancing over a wave larger than the statistically average one. It means that at the time of taking adverse course to waves in heavy storm, the occurrence of structural damage at the bow or dislocation of the hatchcover was highly probable.

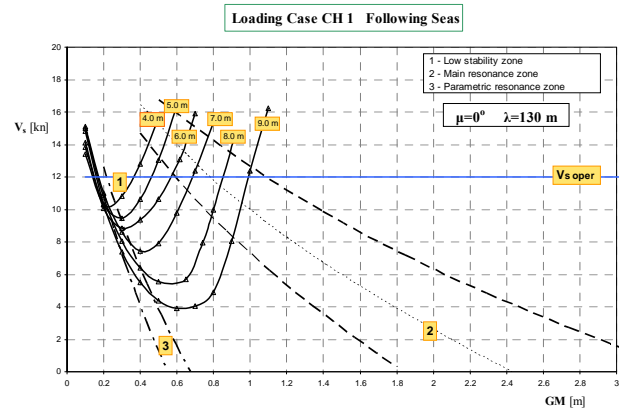
Figure 4. Diagram of endangered stability in following seas for the intact ship.

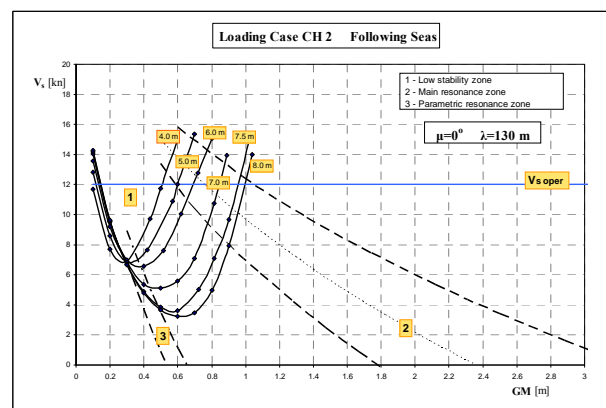
The diagrams for the safe operation in following seas for the three loading conditions are shown in Figs. 4 – 6. It can be seen that when sailing with heel and trim and taking into account the newly formed free surfaces in the partially flooded cargo holds, the vessel falls into an unfavorable zone which endangers her

operational stability. More specifically, at significant wave heights over 5 m, after the instance of water penetrating the holds and forming free surface the ship becomes unstable.

Figure 5. Diagram of endangered stability in following seas for the damaged ship – Hold № 1 flooded, static heel 9°, 1.30 m trim to bow.

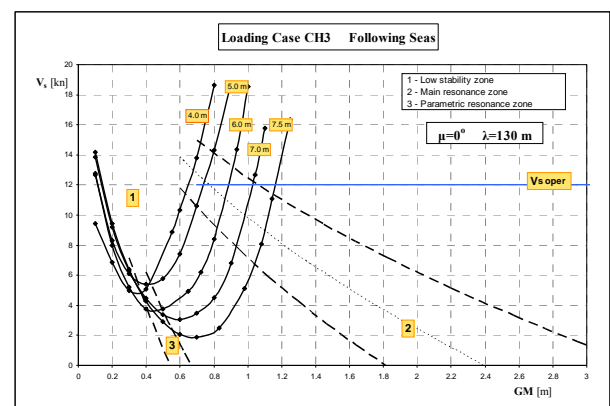
Figure 6. Diagram of endangered stability in following seas for the damaged ship – Hold № 1 and forepeak flooded, static heel 9°, 2.45 m trim to bow.

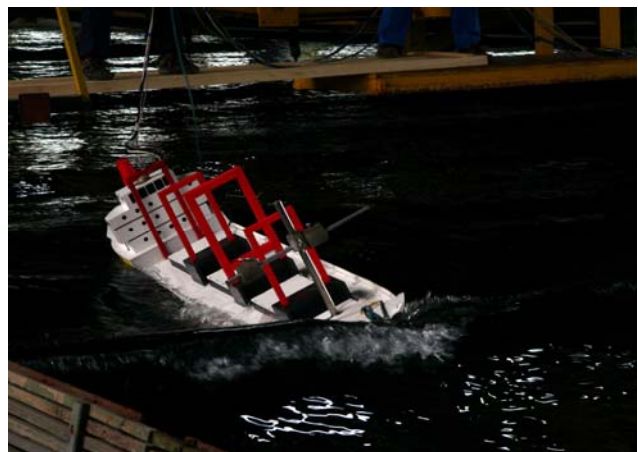
From the model responses observed it could be concluded that even at considerable heel and trim in extreme seas the ship retains positive stability until the moment of hatchcover loose. The crucial circumstance for the accident happened to be the water ingress in bow compartments, which sharply reduces stability due to the newly formed free surface. In that condition, passing of an extremely high wave forces the ship to ride-on, restoring forces rapidly decrease and the ship capsizes.

Figure 7a. Final phase of surf-riding – large wave is passing along the ship, water is pouring into an opening in the hold.

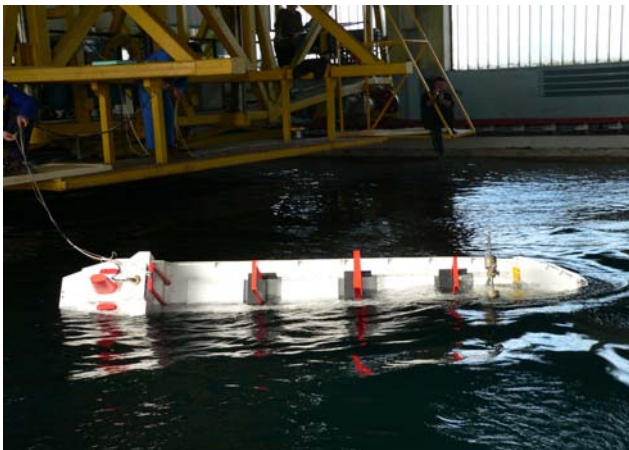
Figure 7b. Ship losses stability.

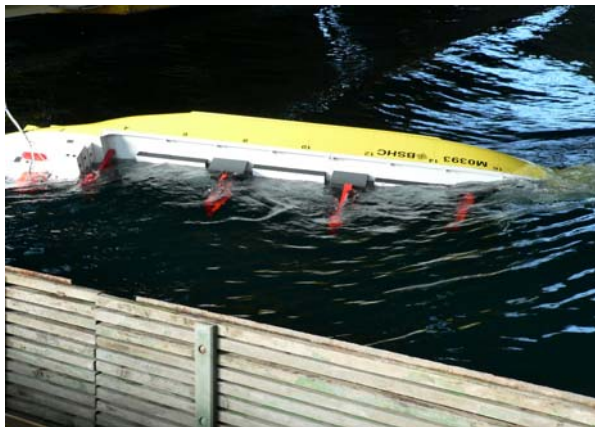
Figure 7c. Ship capsizes.

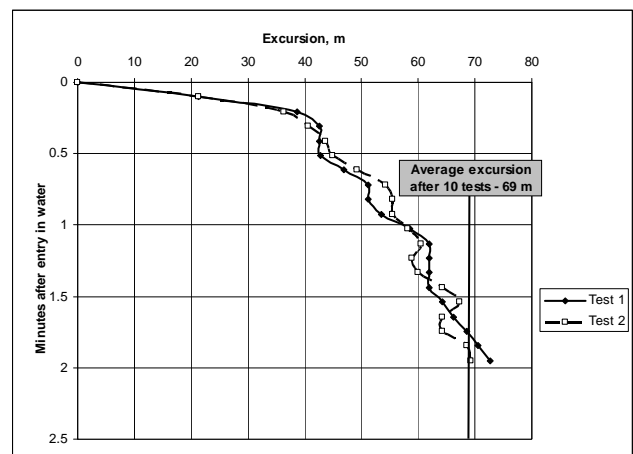
Figure 8. Falling trajectory of the hatchcover of Hold № 1 in case of entering into water with the edge ahead.

Based on the test results it can be stated that the hatchcover’s fastening dogs have been loosed in advance, maybe by green water chancing on deck during storm ride, and the shock of collision with the ground at the moment of sinking provoked final disengagement.
