Pure loss of stability in stern quartering waves: revisited with numerical simulations reproducing accidents

ABSTRACT

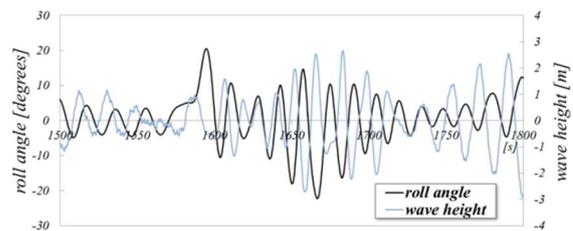
An example of the numerical simulation results using the fore-mentioned model with the roll restoring variation due to waves is shown in Figure 1. The wave elevation at the midship and the roll angle are shown as time series: the negative wave elevation indicates the wave elevation from the calm-water surface and the positive roll angle does the roll towards starboard. The roll period is generally the same as the wave encounter period so that the obtained roll motion is harmonic. When the ship meets a wave crest or shortly before a wave crest, the ship significantly rolls towards starboard side. This seems to be a typical pure loss of stability

but significant rolls towards port side also happens. If the phenomenon is harmonic, the significant rolls also for port side is natural and the restoring variation could be a major source of large roll.

Figure 1: Numerical simulation of the RoPax ship with the roll restoring variation.

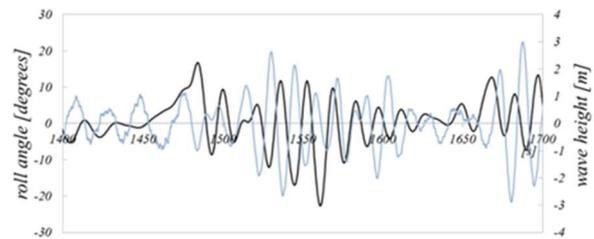
For directly investigating this hypothesis, the numerical simulation without the restoring variation is also executed and its result is shown in Figure 2. The maximum roll angle here, as well as the qualitative nature of the relationship between the roll and waves, is the almost the same as the simulation with the restoring variation. This suggests that the roll restoring variation is not a major cause of the significant roll.

Figure 2: Numerical simulation of the RoPax ship without the roll restoring variation.

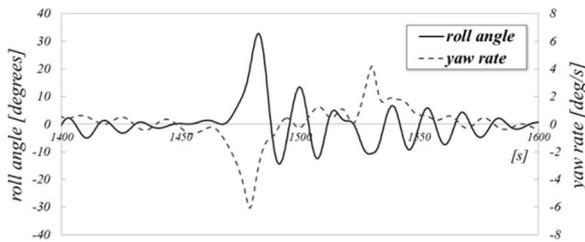
The simulated results also indicate that the wave encounter period is about 17.5 s, which is close to the natural roll period of 17.1 s. Thus we may suppose that the significant roll could be a simply harmonic resonance of uncoupled roll motion in stern quartering waves. If so, the major cause could be a wave exciting roll moment. For examining this hypothesis, the numerical simulations with and without the effects of sway and yaw to roll are executed and their results are shown in Figures 3-4. Here the yaw rate and the roll angle are shown as time series: the positive yaw rate indicates the increase of yaw angle towards a starboard turn. It is clearly seen in Figure 4 that large yaw rate towards port results in a large starboard heel and the large yaw rate towards starboard does in a large port heel. This is well known tendency as a result of yaw-roll coupling. On the other hand, if we ignore such

Figure 3: Numerical simulation of the RoPax ship with the roll restoring variation and the coupling effect from sway and yaw to roll.

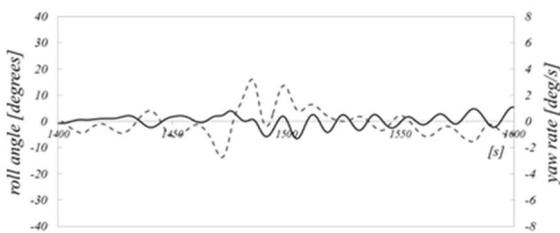
coupling effect, no significant roll as well as no significant yaw rate cannot be found. Therefore, we should conclude that the significant roll that the Ropax ship experienced is a harmonic resonance due to coupling from the yaw motion. More systematic numerical investigation including the ensemble average of the maximum roll and the effect of fin stabilizer was published in Osugi et al. (2019). The yaw-roll coupling mentioned here seems to be identical to “dynamic loss of stability due to surge-roll-yaw coupling” identified by de Kat and Thomas (1998) in their experiment of a frigate model with the artificially lowered GM in stern quartering waves, in which the model typically capsized at a wave crest. They also noted that this phenomenon is different from “quasi-static loss of transverse stability in wave crest” that they also found. Since both phenomena occurred at a wave crest, they are not easily distinguished. Indeed, Kan et al. (1990) regarded rather dynamic phenomenon observed in their experiment of a containership model at a wave crest as “pure loss of stability”. Further discussion is needed.

Figure 4: Numerical simulation of the RoPax ship with the roll restoring variation and the coupling effect from sway and yaw to roll.

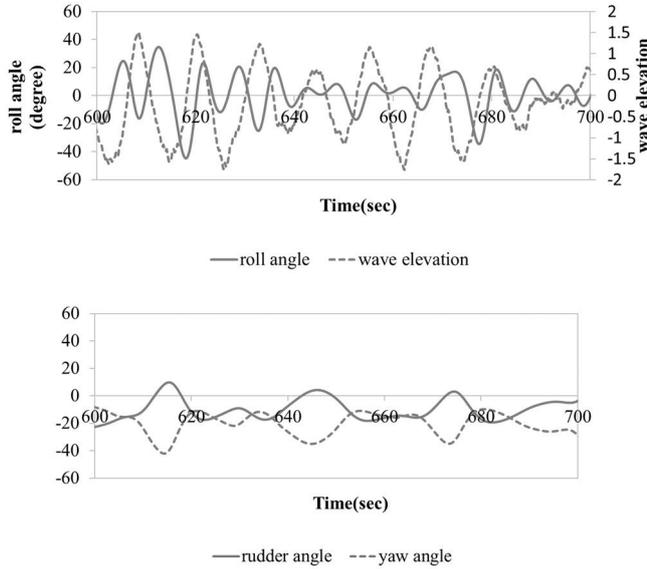
For investigating the reason why large roll occurs, comparative simulations were executed. Firstly, the time series of numerical simulation with and without the roll restoring variation for a typical case are shown in Figures 5 and 6, respectively. Here the wave elevation indicates its value at the midship and its minima correspond to a wave crest. The positive roll angle means the starboard downwards, the positive yaw angle does the starboard turn and the positive rudder angle normally induces the starboard turn. As shown in Figure 5, a large roll angle of about 35 degrees towards port side occurs shortly after the wave crest amidship. This seems to be relevant to a pure loss of stability. However, it is noteworthy here that at the moment the yaw rate towards starboard side becomes very large. It could induce large centrifugal force due to this large yaw rate, which could result in large heel towards the port side. Indeed, the numerical simulation without the restoring variation, as shown in Figure 6, shows that

Figure 5: Numerical simulation of the ocean research vessel with the restoring variation.

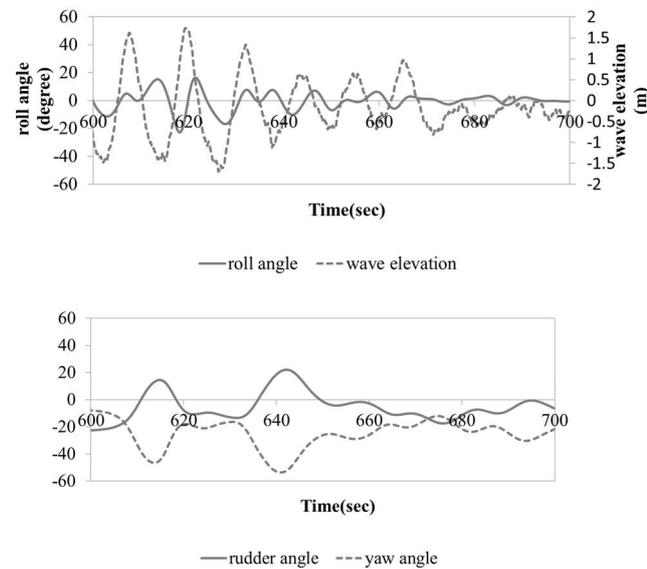
slightly smaller but still more than 20 degrees roll occurs at the relevant moment. Therefore, we should conclude the roll restoring variation is not the only reason of large roll.

Figure 6: Numerical simulation of the ocean research vessel without the restoring variation.

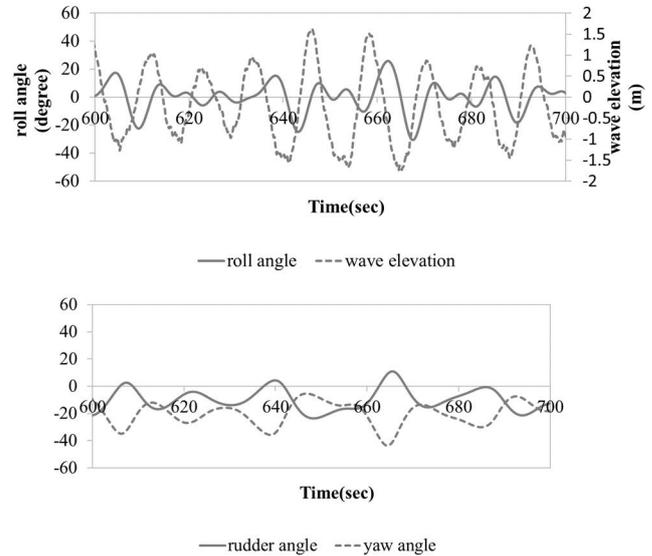
For more directly confirming the reason of large heel, the numerical simulation without roll damping components due to sway velocity and yaw angular velocity was executed as shown in Figure 7. This indicates that the roll angle becomes further reduced from about 35 degrees to about 7 degrees. Thus, we can conclude that the coupling between sway/yaw and roll is also a major reason of the large heel at the wave crest amidship. Therefore, we can presume that

both roll restoring variation and the roll-sway/yaw coupling are important for large heels in stern quartering waves.

Figure 7: Numerical simulation of the ocean research vessel without the roll damping components due to sway velocity and yaw angular velocity.

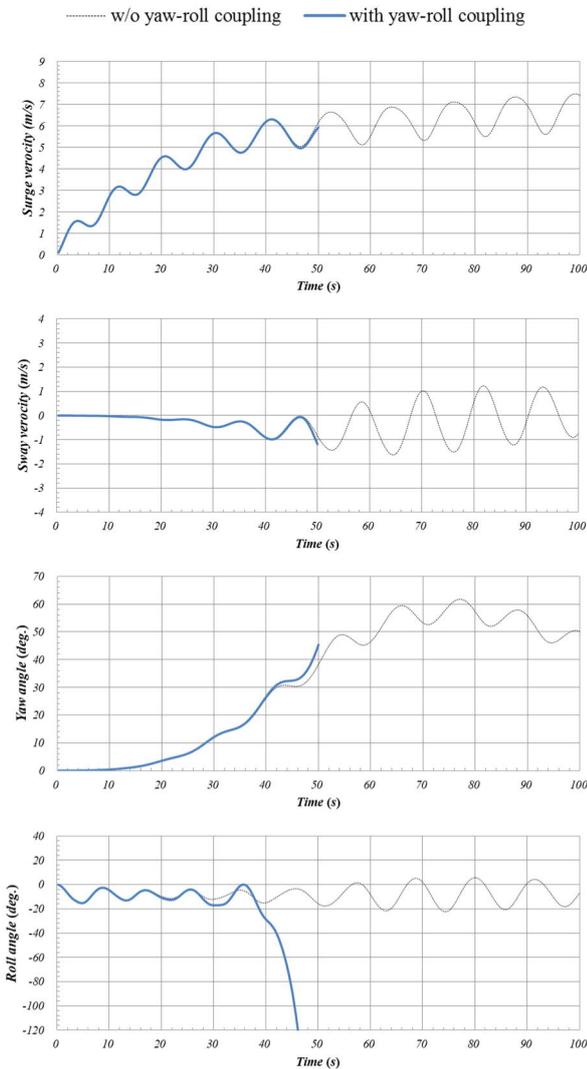
Figure 8: Numerical simulation of the torpedo boat with and without yaw-roll coupling. Here the wave steepness of 0.06, the wavelength to ship length ratio of 1.0, the Froude number of 0.26 and the heading angle of 50 degrees from the wave direction.

In order to explain the accident, the 4 DoF (surge-sway-yaw-roll) numerical simulation model mentioned before was utilized with the wave and operational conditions at the accident. A constant heel angle due to wind was also considered. Figure 8 shows the simulated results with and without the yaw-roll coupling.

The simulated result with yaw-roll coupling demonstrates that the ship rapidly turns to starboard side and then capsizes to port side. This is the same as the accident report (Matsumoto, 1954). On the other hand, the ship does not capsize if we ignore yaw-roll coupling in the numerical model.
