Study on the motions and flooding process of a damaged ship in waves

ABSTRACT

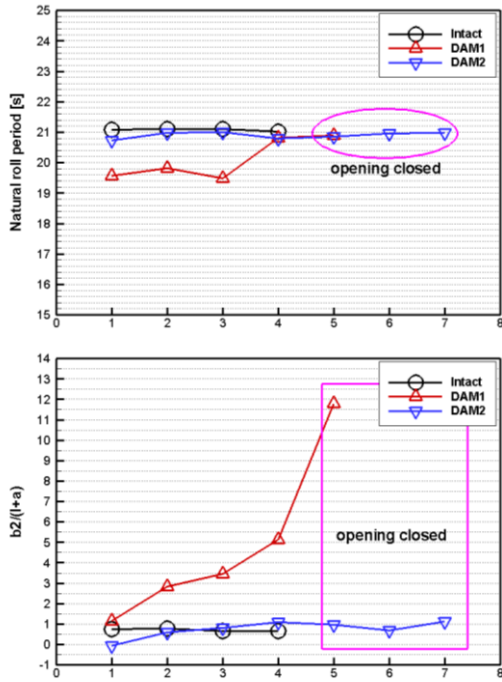
Fig 6: Results of free decay

Fig 5 shows the roll free decay test results. The natural roll period for DAM1 decreases about 1 sec due to flooding, heeling, free surface etc. The quadratic damping for DAM1 is different with intact. When opening is open condition, damaged part is not symmetric and flow in/out occurs in the CP10-R1S. This indicates that the estimation of damping is difficult when a damaged part is severe. The closed condition is

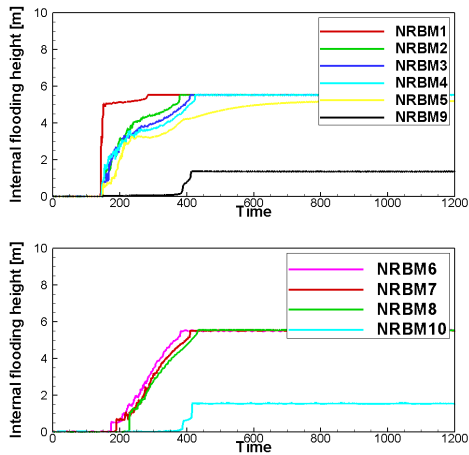
Fig 7: Flooding process of DAM1

The flooding test was performed in calm water for DAM1 and DAM2. Fig 5 and Fig 6 shows the results for DAM1. The flooding through the opening starts at CP10-R1S (RBM1) and continues to CP10-R1C (RBM2,3,4) and CP10-R1P(RBM5). The water instantly fills up CP10-R1S. After filling of CP10-R1S, water propagates into other compartments. The RBM6, 7 and 8 show the flow from CP10 to CP11. The required time for flooding second floor, CP10/11-R2 is about 240 sec and the steady state value of roll angle is 5.14 deg. Fig 6 shows the motions with flooding. Roll motion begins at the same time with flooding and reaches the steady state (~400 sec) after filling of CP10-R1S/C/P. The flooding process of DAM2 is shown in Fig 7 & 8. The flooding process and motions are quite simple due to simple geometry and configuration. The flooding starts at CP17-R1 and flooding water reaches to the bottom of CP17-R2. The amount of water in CP17-R2 is small.

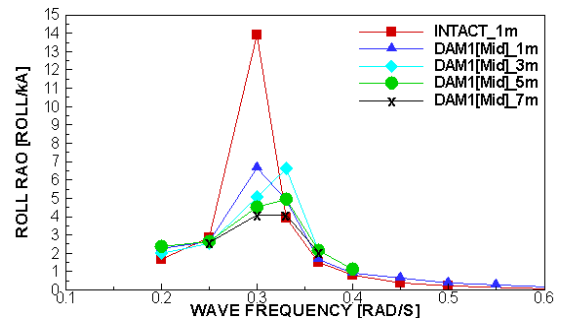
Fig 9: Roll RAO of intact

Fig 10: Roll RAO of DAM1

Fig 11: Roll RAO of DAM2

The motion tests in waves were carried out in the condition that the compartments were flooded. This gives the same situation at initial condition. The results of motions in waves are shown in Fig 9~12. The wave amplitudes are 1, 3, 5, 7 m to assess the effect of nonlinearity of the incident waves. The heave RAO shows there is no effect of wave amplitude and damage. But the roll motion is significantly influenced by wave amplitude and damage conditions. Interestingly enough, the effect of wave amplitude on roll motion also appears in intact condition. The peak value of roll RAO decreases at resonance frequency when wave amplitude increases. In case of DAM1, roll RAOs are changed due to internal water motion and inflow/outflow. The resonance frequency moved from 0.3 rad/s to 0.33 rad/s due to sloshing. The effect of internal water motion appears for wave amplitude 3, 5, 7 m and sloshing occurred in CP10/11-R2. This is sloshing in low filling ratio. When wave

amplitude is 1m, the internal water motion is small and sloshing doesn't occur. In order to excite sloshing in a considerable level, waves more than 3 m should be incident because the ship heels 5.14 deg to starboard. Fig 14 shows the sloshing by roll motion. In case of DAM2, roll RAOs is similar to intact RAOs. Although sloshing in CP17-R2 occurs, there is no significant influence of flooding because of small amount of water. Fig 13 shows the effect of opening and in/outflow.

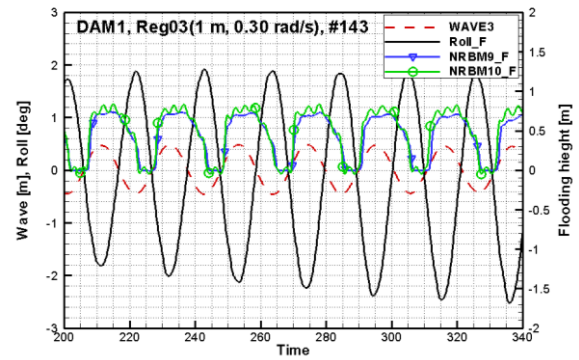
Fig 12: Motion and flooding of DAM1 (wave height 1m, $\omega=0.3$ rad/s)

Fig 15, 16 & 17 show the roll motion and internal water motion in CP10/11-R2. The position of water height measurement (RBM9/10) is in the middle. The initial value of water height is zero in flooded situation. The positive value stands for increasing and negative value decreasing. When wave height is 1 m, flooding water doesn't reach to port side wall and sloshing doesn't occur. But in case wave height 5 m, flooding water reached port side wall. When wave frequency is 0.33 rad/s, the coupling of sloshing and roll is strong. Table 2 shows the phase of roll and incoming wave due to sloshing.

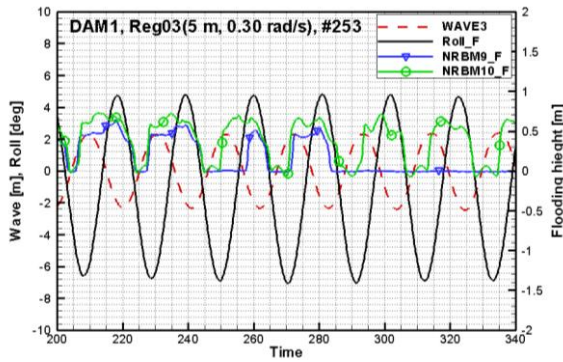
Fig 13: Motion and flooding of DAM1 (wave height 5m, $\omega=0.3$ rad/s)

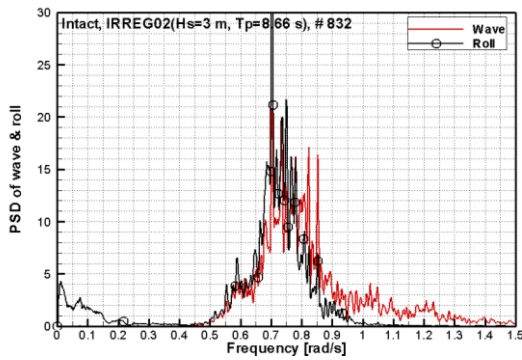
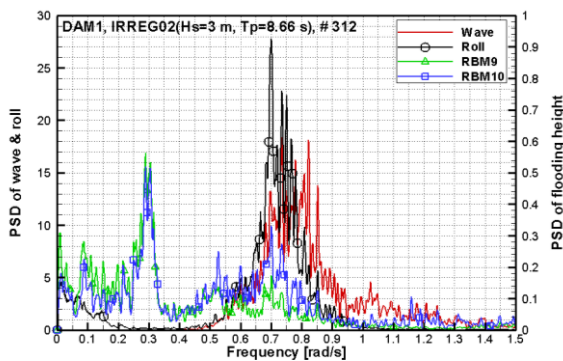
Fig 15: PSD of intact in irregular wave ($H_s=3$ m)

Fig 16: PSD of DAM1 in irregular wave ($H_s=3$ m)

Fig 15 and 16 show the irregular test results for intact and DAM1. The flooding affects the roll motion and the roll motion decrease. Also the motion of flooding water is clear at 0.3 rad/s.

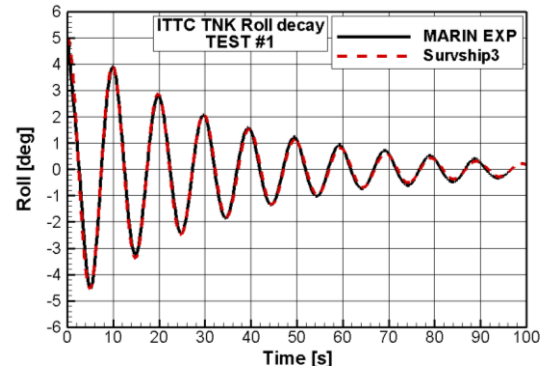
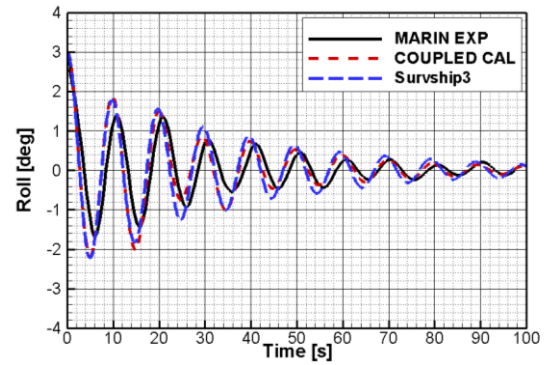
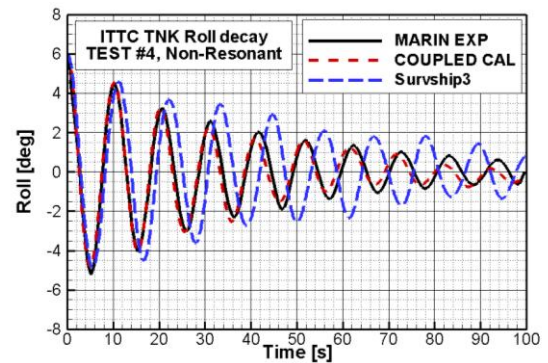
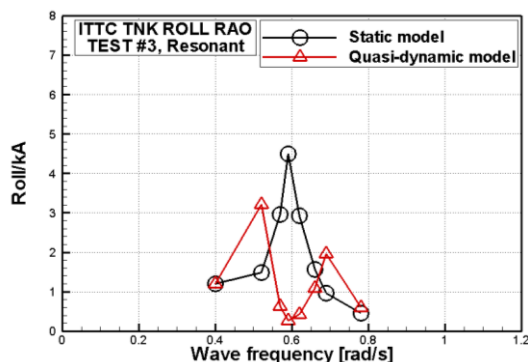
Fig 17: Free decay ($h=0$ m)

Fig 18: Free decay-sub resonance ($h=3$ m)

Fig 19: Free decay-resonance ($h=4$ m)

Fig 20: Free decay-non-resonance($h=16\text{m}$)

Fig 21: Roll RAO-resonance($h=4\text{m}$)

Fig 17~21 show the results for ITTC tanker model. The free decay results of quasi-dynamic model are pretty similar to experiments and CFD. This indicates that the quasi-dynamic model can calculate the dynamics of free surface. Also regular wave test shows the reasonable results. The merit of quasi-dynamic

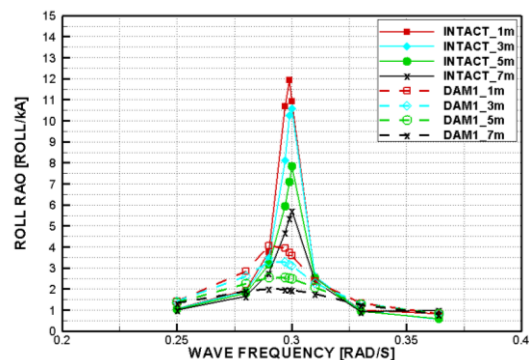
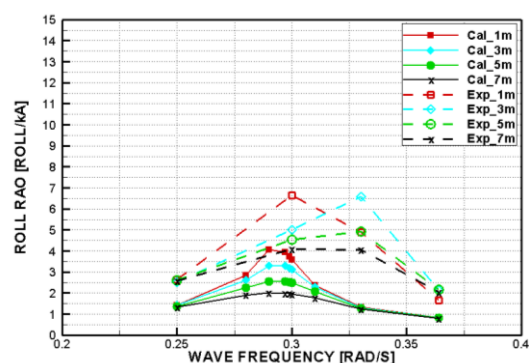
Fig 25: Roll RAO for intact and DAM1-Quasi-dynamic model

Fig 26: Roll RAO comparison for DAM1-Quasi-dynamic model

The damaged problem is calculated by quasi-dynamic model. The results are shown in Fig 23~26. The transient flooding process is represented by the model. The flooding heights are compared and the numerical results agree with experiments. But the roll is different at flooding beginning. This difference is due to the different amount of flooding water in CP10R1S. The increase of numerical result in CP10R1S is almost step and CP10R1S is full. But experiment shows CP10R1S is not filled once and is full after 150 sec. This lag may be occurred by air compression and numerical model limit. Fig 25 and 26 show the regular wave results. Roll RAOs show similar tendency of experiments.
